**Subject:** Elevated Engine Coolant/Operating Temperatures with Snow Plow Mounted

**Models Years Affected:** 2014 and beyond  
**Models Affected:** Chevrolet Silverado  
GMC Sierra  
Upfitted with a Snow Plow  
**Origination Date:** June 1, 2016  
**Revision Date:** March 1, 2019

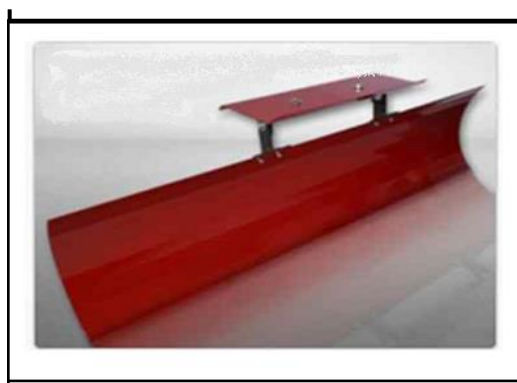
Both of the above conditions can occur due to the reduced airflow into the radiator area with the plow in the raised position. The air flow is diverted upward as a result of the raised plow and thereby does not enter the front grille area of the vehicle.

- Try lowering or repositioning (angling) of the plow.
- If repositioning attempts are unsuccessful in reducing the operation temperature, GM recommends that an after-market air deflector be added to the top of the plow, similar to the one shown below.
